# Manhole Inspection Summary

Manhole # S41W\_\_024MH

Insp Date: **2/28/08 7:40 AM**

**Location** Address: **Phillips plant off E. Fort Avenue (1200 block)** Cross Street: **Woodall Street**

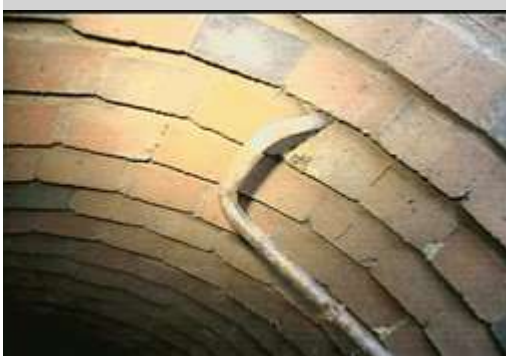
Defect 3

**Steps** Count: **4** Missing: **0** ☒ **Corroded**

corroded step

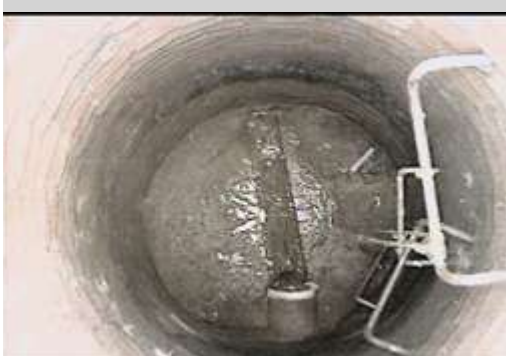
Defect 1

**Surcharge** ☒ **Evidence Of Surcharge** Depth: **6** (ft.) ☐ Active Surcharge Present

Surcharge Evidence
